## **Demonstration and Validation of Advanced Rebar Materials in Salt-Exposure Applications**

Final Report on Project F09-AR13

Under Project F09-AR13, "Evaluation of State-of-the-Art Rebar Concrete Structures in  
Salt Environments at Fort Knox, KY"

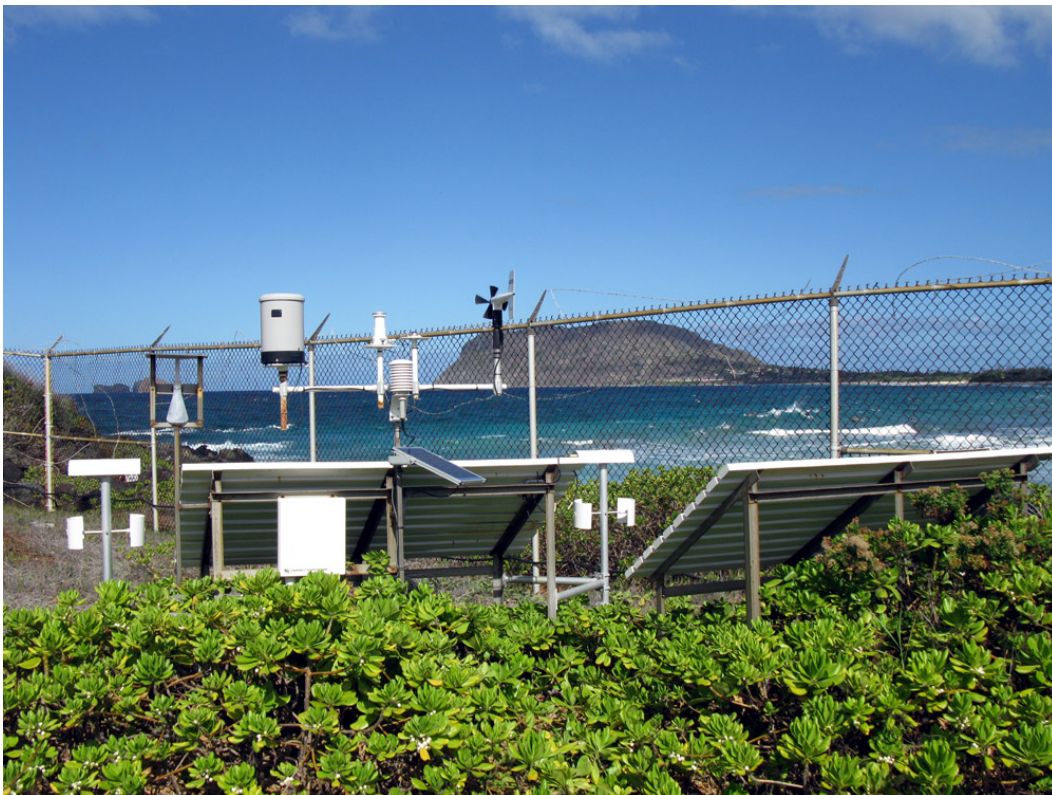
Figure 1. Exposure test site in Hawaii.

In addition to the field demonstration, a nonstandard exposure test was conducted by placing samples of each material used in the demonstration on a corrosion exposure rack at an extreme exposure site in Hawaii. The site is on the northern shore of Oahu and subject to constant salt water spray and high temperatures (Figure 1). Each specimen was bent 180 degrees prior to exposure. This nonstandard test was performed to visually observe the relative corrosion resistance of the materials and whether bending the materials impacted their corrosion resistance.

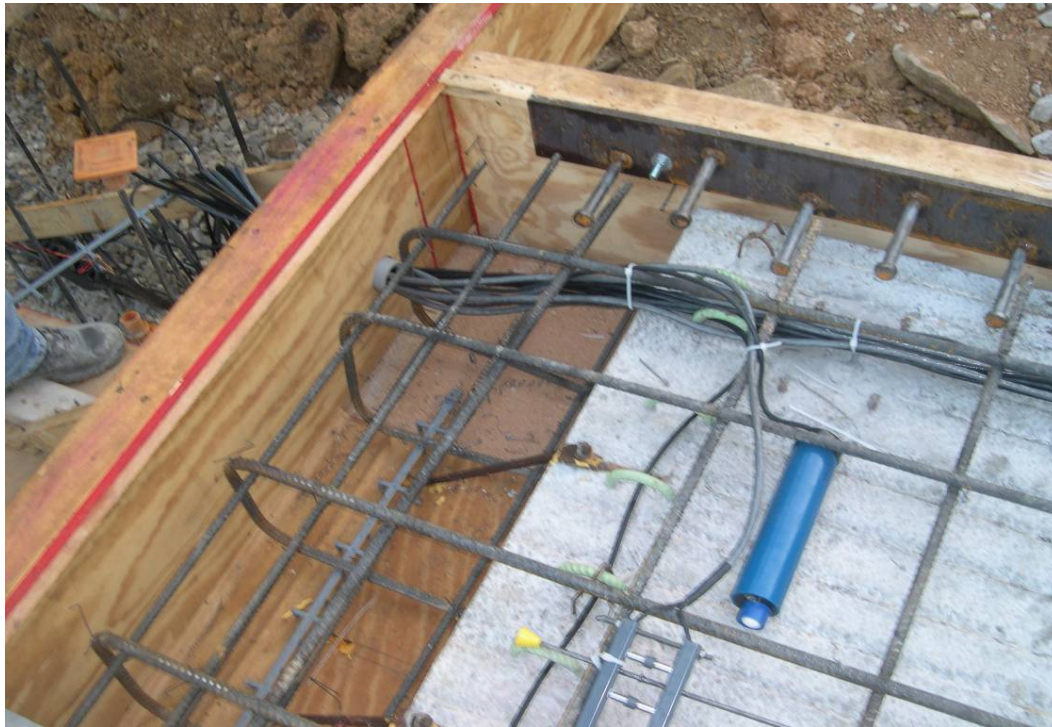
*To measure corrosion potential*, Stelth 7 silver/silver chloride reference electrodes\* were placed at strategic locations across the structure. Potential measurements could then be obtained and monitored for corrosion activity over a stated period of time. The reference electrodes were attached directly to the rebar and mounted as shown in Figure 2.

Figure 2. Corrosion potential reference electrodes (blue).

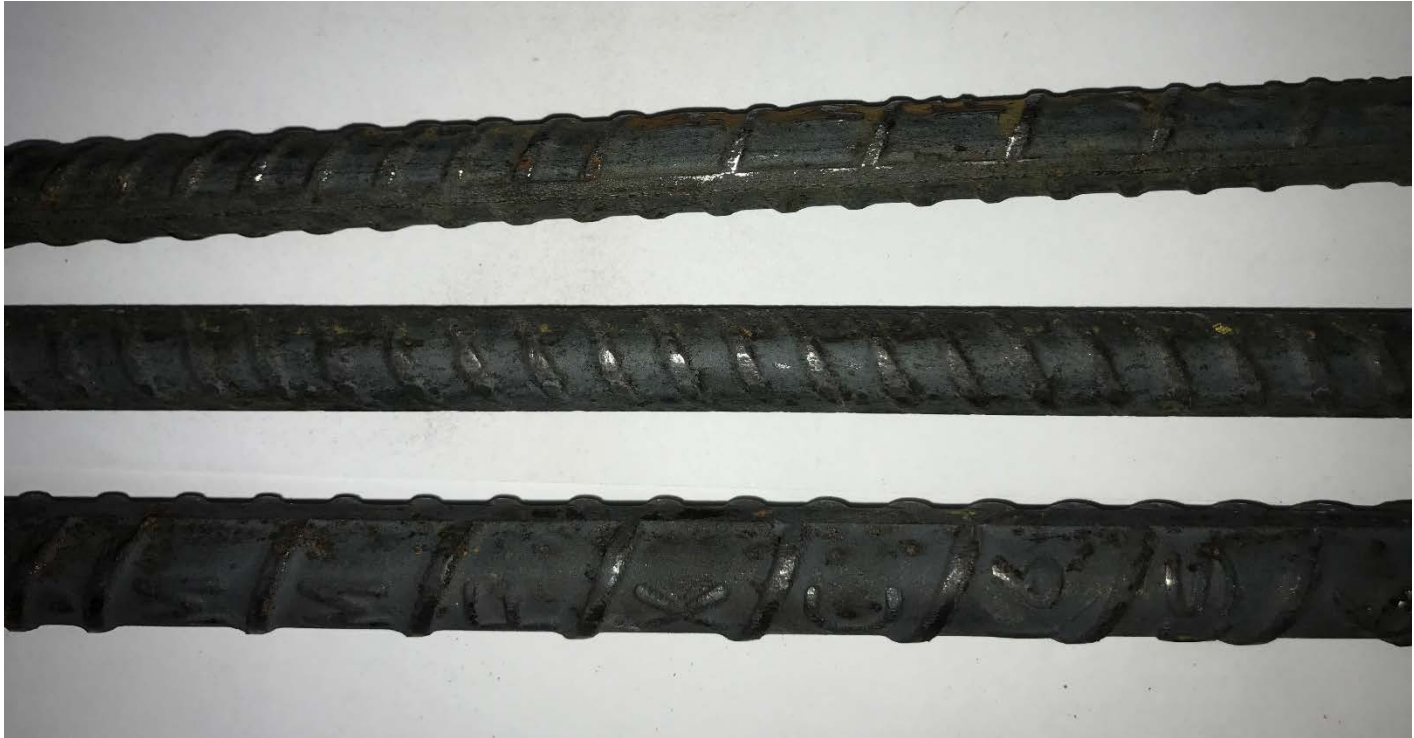
As previously stated, one material tested was MMFX2 rebar (Figure 4). This material was installed in Bridge 9, a conventional steel beam structure with a poured concrete cap. However, the replacement bridge used precast, reinforced, stressed beams with a concrete deck cap that was constructed using the MMFX rebar (Figure 5). Sensors were installed in the deck cap at five locations. A deck cap's thickness varied from 4 to 7 in. and had a brushed concrete veneer.

Figure 4. Samples of MMFX2 rebar installed at Bridge 9.

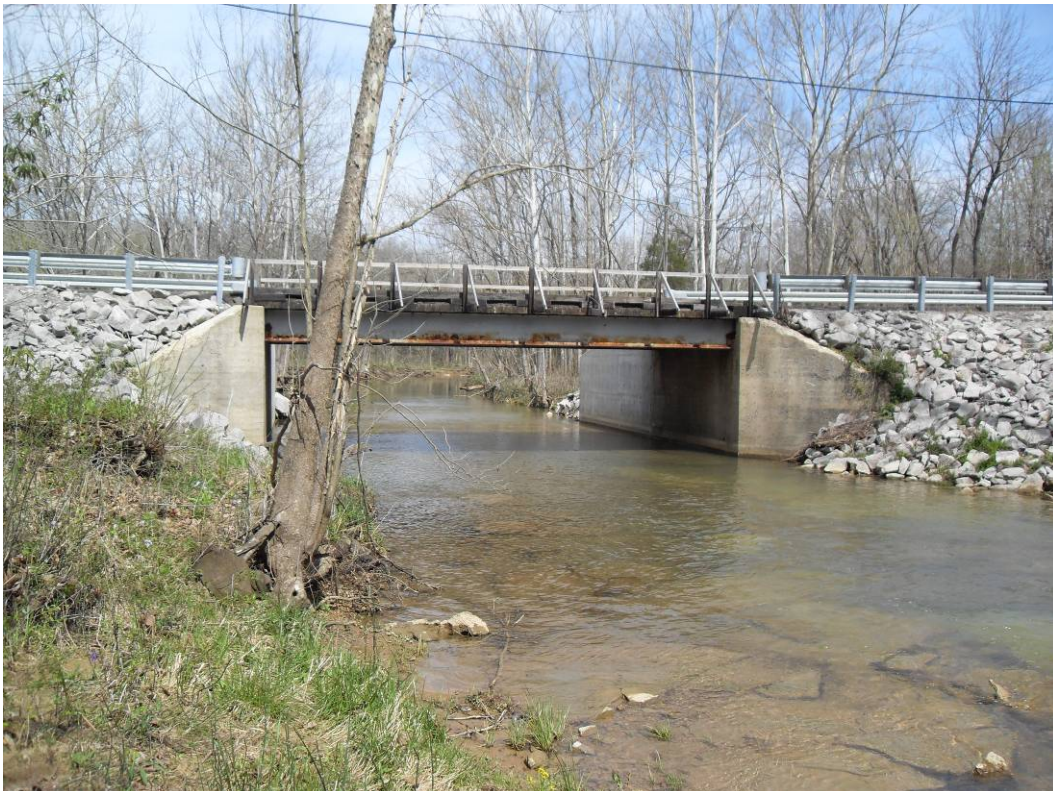
Figure 5. Bridge 9 prior to project initiation, a conventional steel beam structure with a poured concrete deck.

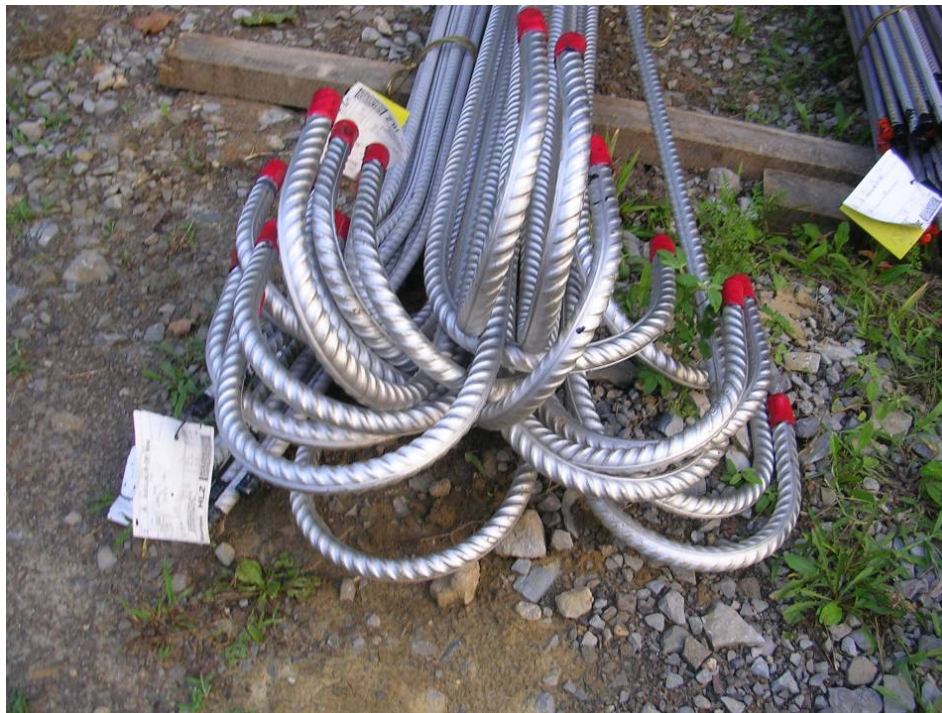
A second material tested was a 316L stainless steel-cladding (SSC) on standard carbon steel rebar (Figure 6). This material was tested on Bridge 42, a box culvert configuration (Figure 7). The concrete box portion of the bridge was constructed using the SSC rebar, then covered with 18 in. of dirt and rock. A 5 in. asphalt cap was installed at the road surface. Three sets of sensors were embedded in the concrete box structure to measure data from the SSC rebar that was buried under dirt and rock (Figure 8). Corrosion potential sensors were installed in this area with stainless steel coupons in the reference electrode. The corrosion rate sensor and multi-depth penetration chloride sensors were installed in the same area. To emulate the testing done on Bridge 9 for chloride penetration, a 3 x 10 ft concrete slab (see Figure 28 on page 26) was poured and installed in the road surface, using SSC rebar along with the three types of sensors. The sensors were installed in the same configuration as Bridge 9, but with two sets of sensors. The only variance in sensor type was the corrosion potential reference electrodes installed in this area. Time constraints, due to construction timetables and procurement of the sensors, dictated that carbon steel coupon inserts had to be utilized in the corrosion potential reference electrodes.

Figure 6. 316L Stainless steel-clad rebar.

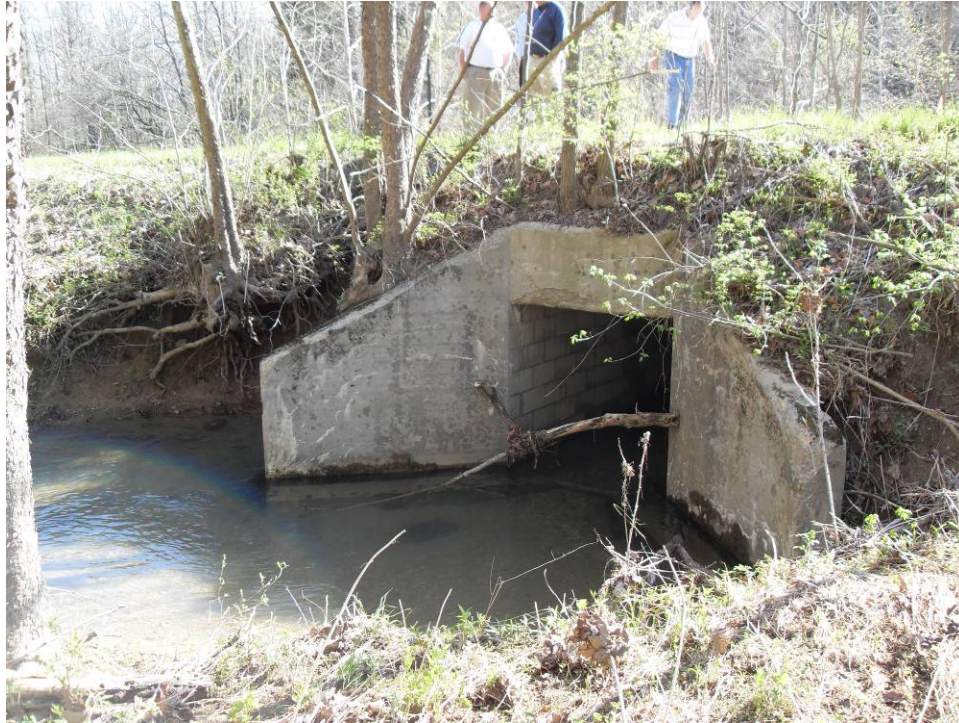
Figure 7. Bridge 42, a box culvert style, prior to project initiation.

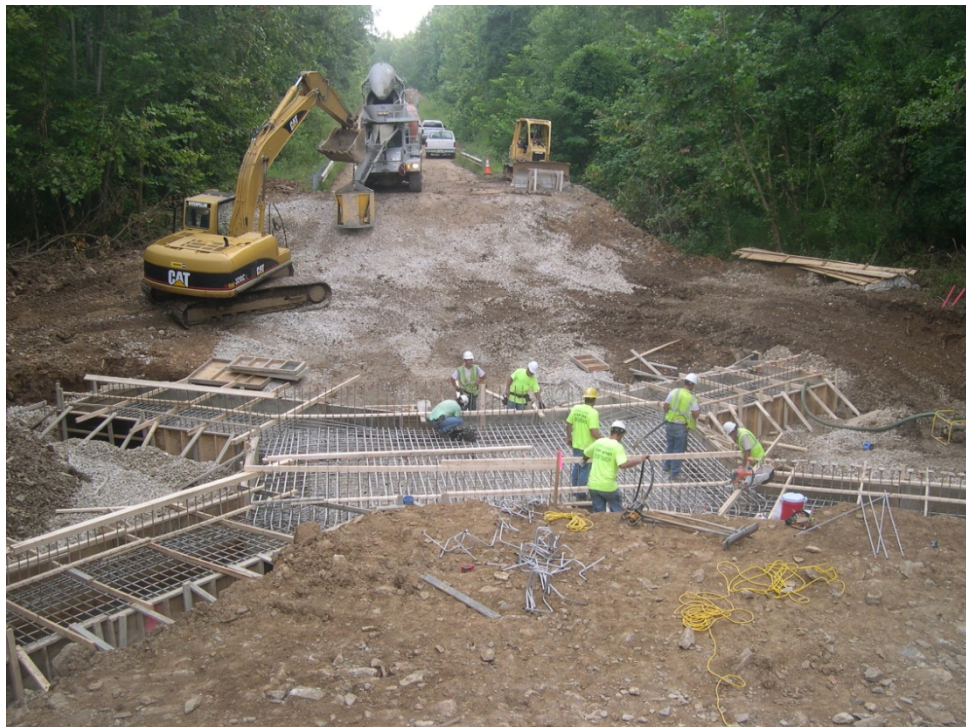
Figure 8. Bridge 42 during construction.

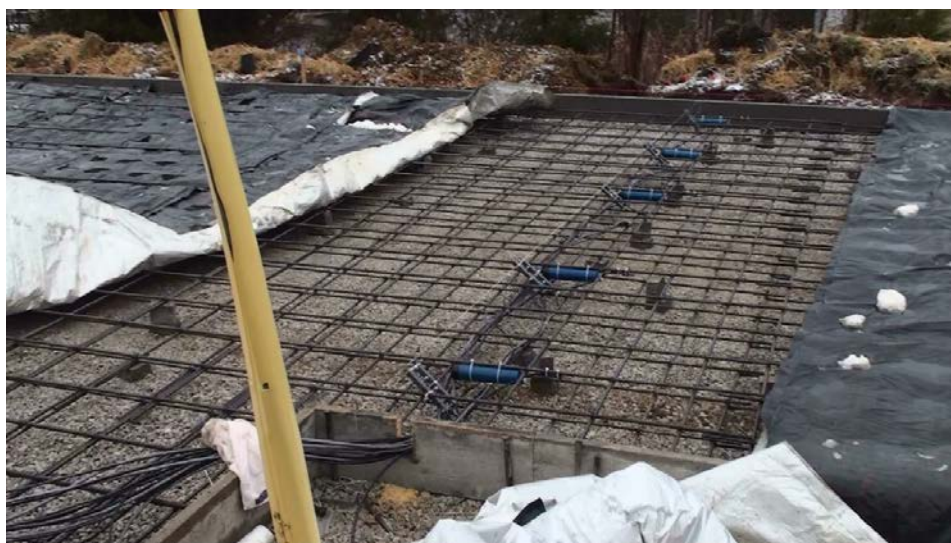
Standard carbon steel rebar, serving as a control, was installed in a poured concrete slab at the south entrance of Hurley Tank Motor Park (Figure 9).

A third bridge was not going to be constructed at this time, so this concrete slab was considered to be a viable alternative to a bridge deck. The concrete slab was approximately 9.5 in. thick, with a standard configuration of steel rebar. Sensors were placed across the width of the site's south entry.

Figure 9. Carbon steel rebar installation at Hurley Tank Motor Park.

Sensors were installed during the final concrete pour across the south entrance of Hurley Tank Motor Park (refer to Figure 9 on page 10). The sensors were arrayed across the entrance at equidistant spacing and installed in the same configuration as the two bridges. All leads were bundled and terminated in a junction box situated on the southwest corner of the entrance gate.

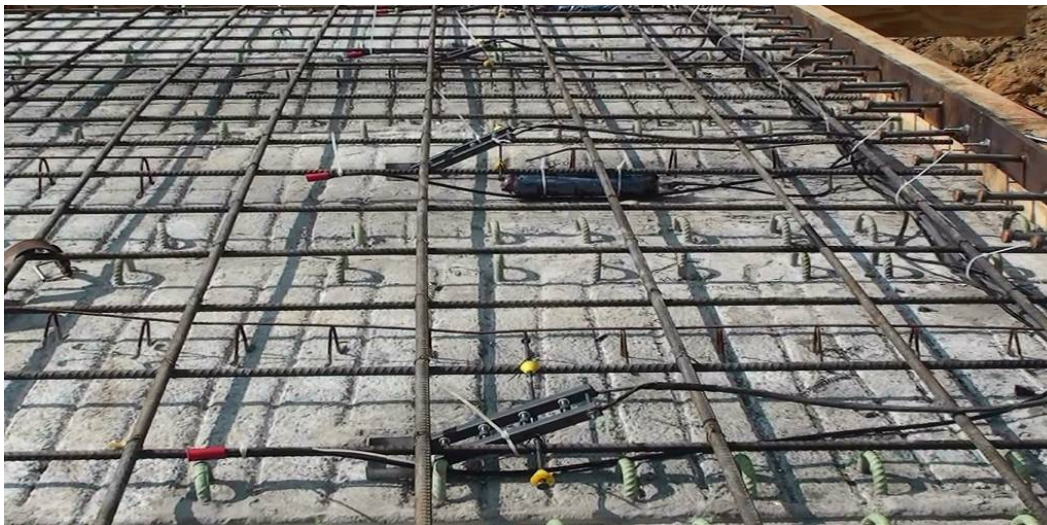
Sensor placements were done during the final pouring of concrete on the structures. Before the final concrete cap was poured on Bridge 9, corrosion potential and corrosion rate electrodes were installed directly to the rebar

across the width of the bridge (Figure 10). The multidepth chloride penetration sensors were installed at the same location as the other electrodes. This ladder-type sensor (refer to closeup shown in Figure 3) was installed from 1 to 4 in. under the surface in 1 in. elevations. All sensor leads were bundled together on the north side of the bridge. The leads then traversed the bridge and terminated in a junction box on the west side of the bridge.

Figure 10. Bridge 9 sensor layout.

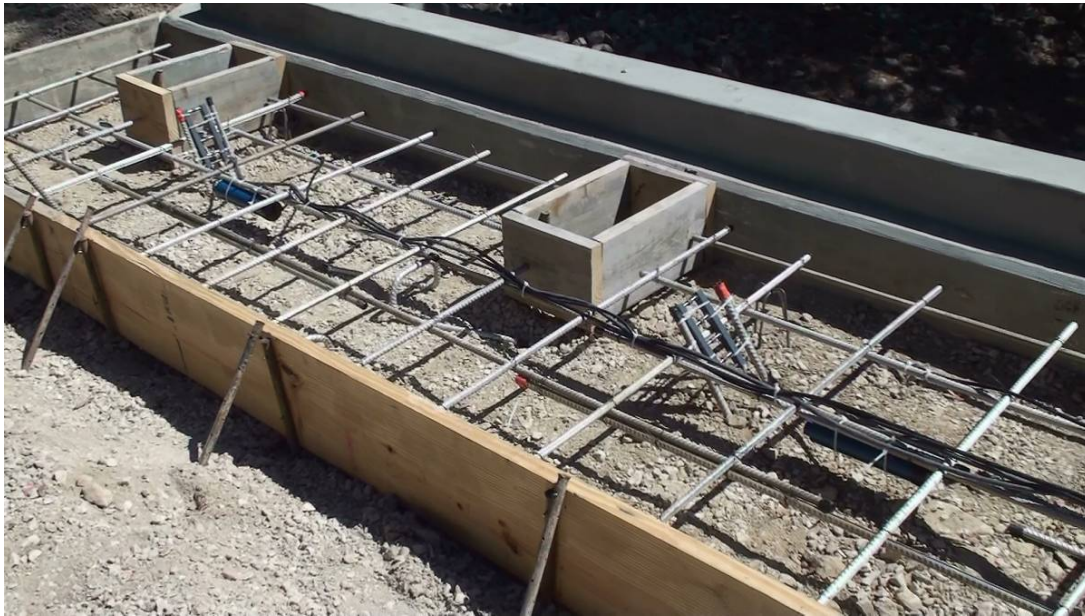
Bridge 42 has the same configuration of sensors as Bridge 9, but differs on the locations of the sensors. Three sets of sensors were installed in the poured concrete portion of the bridge, similar to Bridge 9. However, two sets of sensors were installed in the surface of the poured concrete pad that was installed later (Figure 11). All leads were bundled as they traverse the bridge and were terminated in a junction box located on the south side of the bridge.

Figure 11. Bridge 42 concrete pad sensor layout.

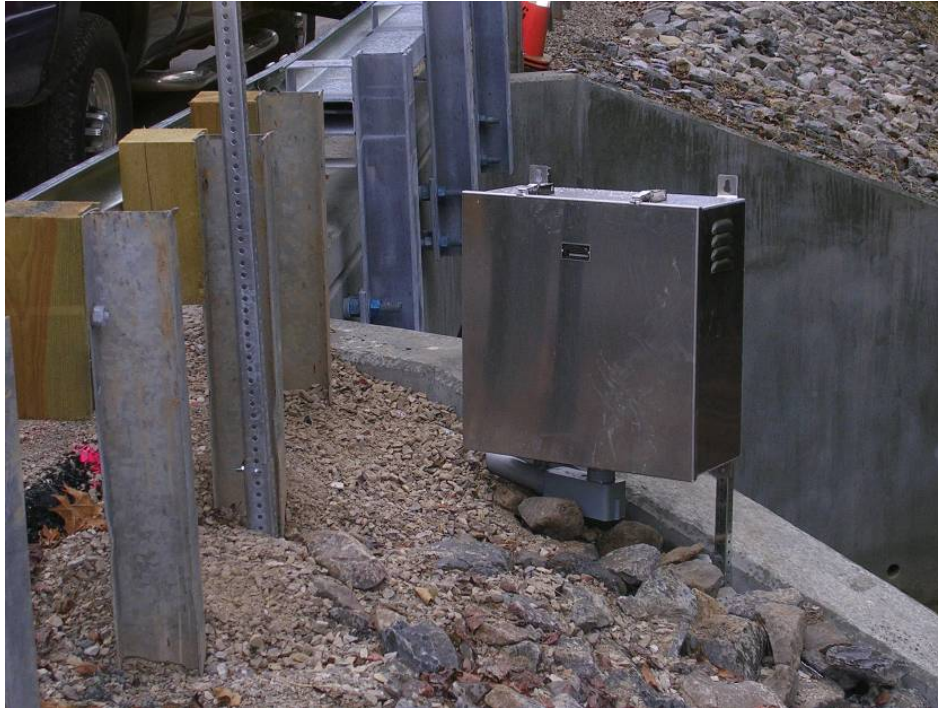
The sensors were accessed and monitored at the corresponding junction boxes for each bridge (Figure 12 and Figure 13). The corrosion potentials were monitored by utilizing a high impedance multimeter in conjunction with the concrete-embedded corrosion potential silver-silver chloride reference electrodes. Potential measurements were obtained and recorded for the duration of the project. Corrosion rate monitoring was accomplished by connection of the corrosion rate dual probe sensor to an AquaMate™ Corrat\* instrument. This instrument is manufactured by RCS and is designed to give instantaneous corrosion rates by the Linear Polarization

Figure 12. Bridge 9 sensor junction box.

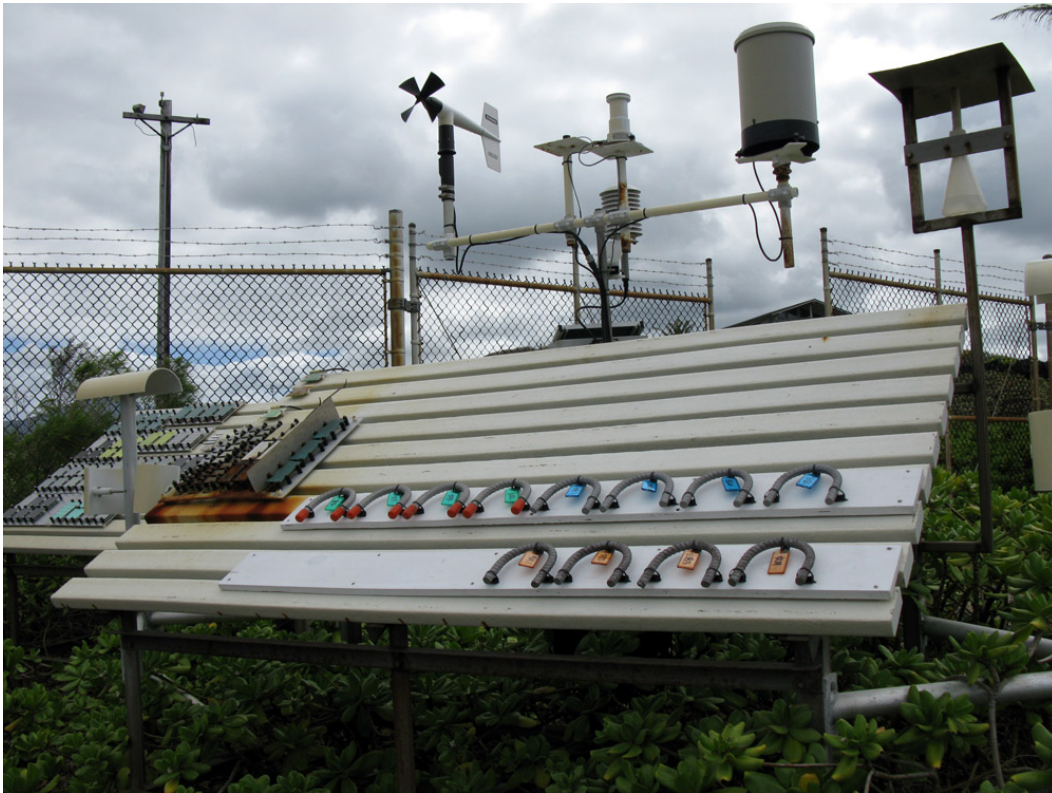
A nonstandard exposure test was performed on samples of each rebar used in the demonstration project. The test's purpose was to subjectively evaluate the relative corrosion resistance between the materials, as well as to see if bending the materials had an adverse effect on their corrosion resistance. Approximately 1-foot long sections of size #5 bars were bent into a U shape with an approximate 2-inch radius. These samples were then placed on an exposure rack operated by the University of Hawaii on the north shore of the Oahu, Hawaii, at Marine Corp Base Hawaii (MCBH). The samples remained on the rack for 1,174 days, at which time the samples were removed, sealed in plastic bags, and shipped to ERDC CERL. The samples placed on the test rack are shown in Figure 14. In the figure, the SSC bar has the green tags, the MMFX2 samples the blue tag, and the plain rebar the orange tags.

Figure 14. Sample rebar on test rack at MCBH.

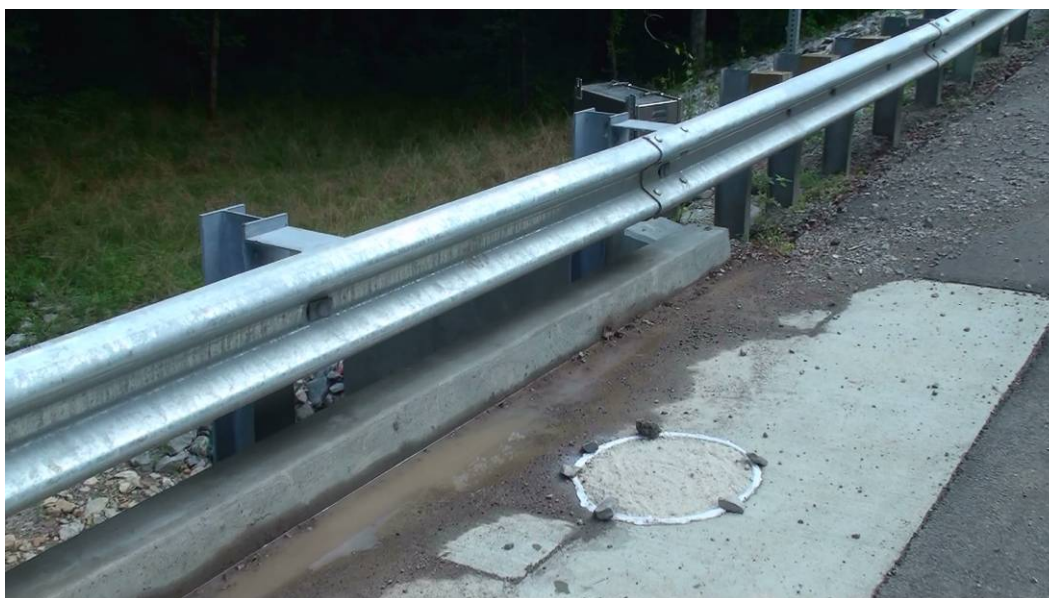
Figure 28. Area above Sensor 4 on Bridge 42 (outlined by white circle), where salt was applied.

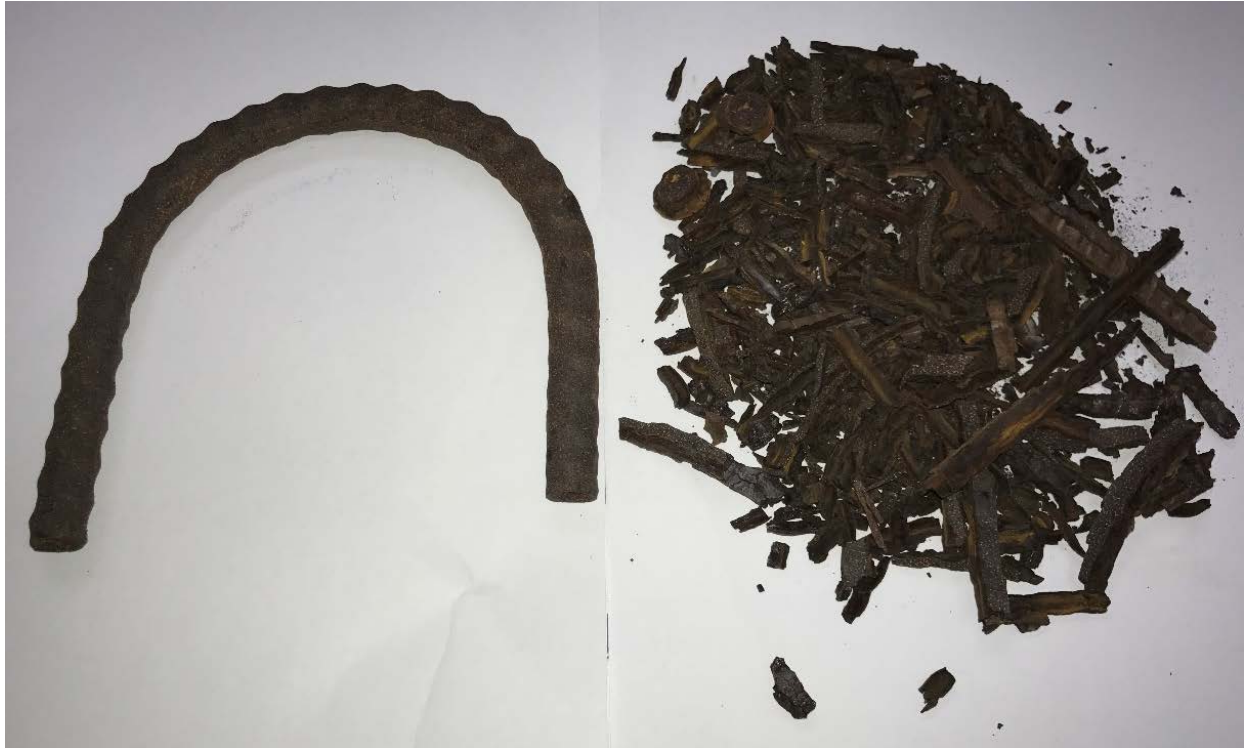
After 1,175 days of exposure at the MCBH test site, the plain reinforcing bar experienced extreme corrosion, as seen in Figure 30. The corrosion products were removed from the bar by hand and are shown piled next to the bar in the figure. The remaining bar measured an average of 3/8 in. in diameter, which represents a 64% reduction in cross-sectional area.

Figure 30. Plain bar after extreme exposure.

The exposure test of the three rebars used in this evaluation in an extreme environment yielded good subjective information regarding the relative corrosion resistance of the materials. The observations from this exposure validate the corrosion resistance assumptions for these materials and also showed that bending the bars did not appear to have any adverse impact on their corrosion resistance.

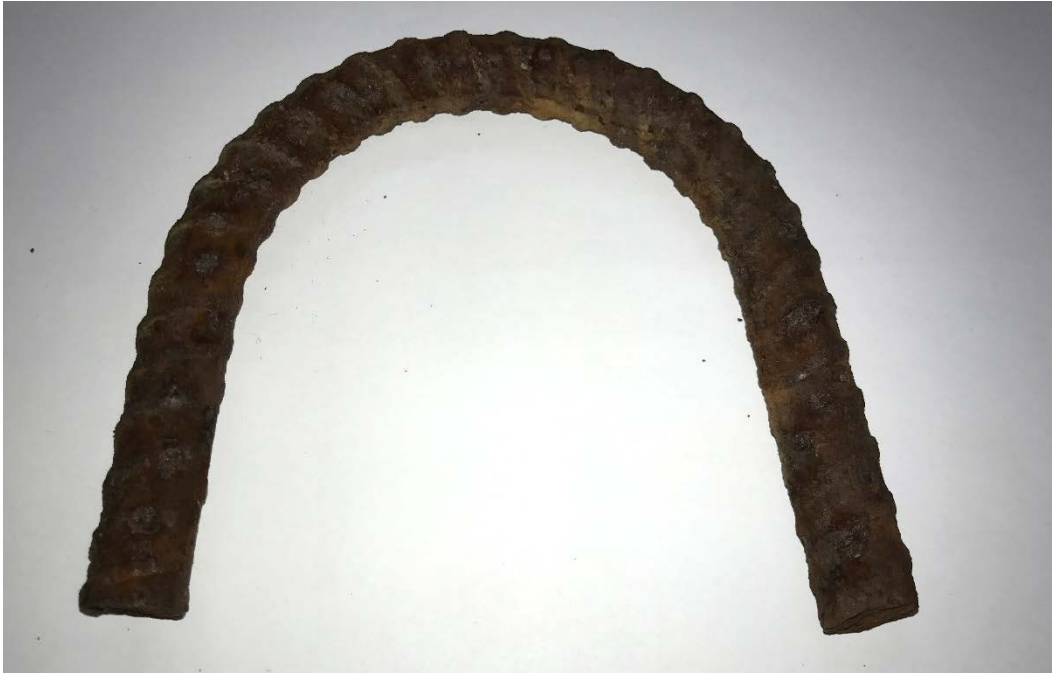
After the same exposure period and conditions, the MMFX2 rebar had a hard layer of surface corrosion, but no measureable loss in diameter (Figure 31). Upon examination, bending the bar did not appear to have a negative impact on its corrosion resistance. Based on these observations, the assumption of a 52-year service life for the bridge deck using MMFX2 rebar is justified.

Figure 31. MMFX2 rebar after extreme exposure.

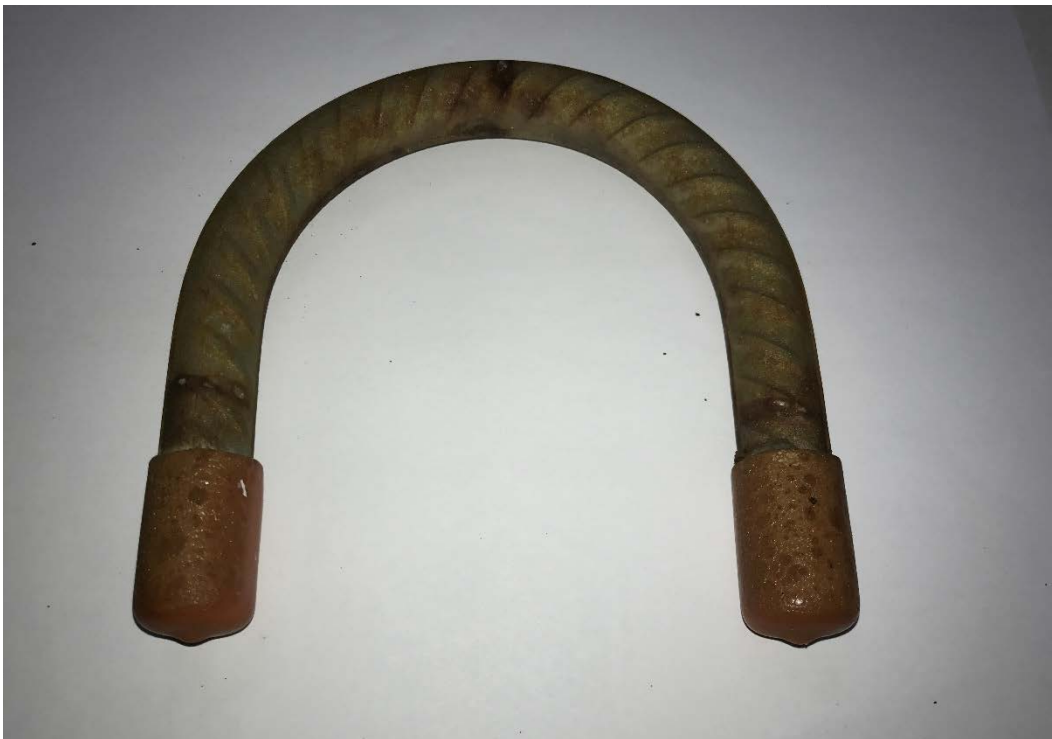
Again, under the same exposure period and conditions, the SSC rebar exhibited little or no surface corrosion, with no measurable loss in diameter (Figure 32). In addition, bending the bar did not have any impact on the corrosion resistance of the bar. Based on these observations, the assumption of a 75-year service life for the bridge deck using rebar SSC is justified.

Figure 32. SSC rebar after extreme exposure.
